# Metal-free Replacement of a Maxillary Lateral Incisor with a Zirconia Ceramic Implant and a Porcelain Fused to Zirconia Crown: A Clinical Report

Sammy Noubissi,  
DDS MS

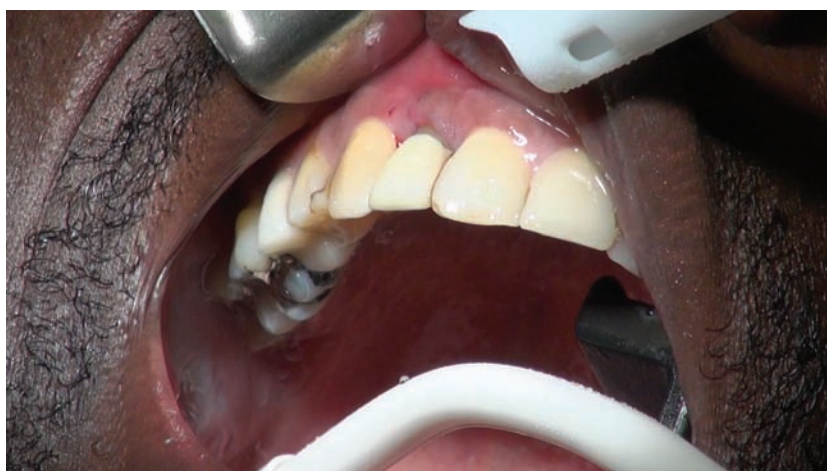
Fig. 1: Pre-Op

A 35 year-old male presented with a failing maxillary right lateral incisor (Fig. 1), the tooth had two root canal therapy done twice, recurrent infection, and an attempt at crown lengthening. Medical and dental histories were taken,

clinical and radiographic exams were performed. Upon clinical examination tooth #7 had type II mobility, 2-3 mm of soft tissue recession. It also appeared on the three-dimensional radiographic examination that the process of crown lengthening resulted with a vertical bone deficiency of a little over 4mm. Examination of the three-dimensional volume (Fig. 2) axial (Fig. 3) and sagittal (Fig. 4) slices of the CBCT confirmed the clinical findings of vertical bone deficiency at site #7. A review of the medical history revealed no contraindications or sensitivity to metal or metal alloys. The patient requested however that a metal-free implant and restoration be used.

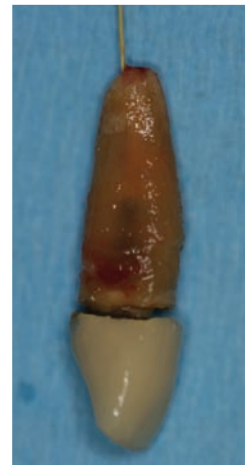
Fig. 6: Extracted tooth

infiltration only in the areas extending from distal tooth # 6 to mesial tooth #9 buccally and palatally . An intra-sulcular incision was made which extended from mesial of tooth #9 to distal of tooth #6. Soft tissue was dissected from bone and no vertical releasing incisions were made. Tooth #7 was extracted surgically (Fig. 6), socket was rinsed and curetted with an ultrasonic piezosurgery (Mectron, Italy) using the round diamond insert. Socket preservation combined with vertical and horizontal bone augmentation was done using synthetic ceramic bone substitute Cerasorb® and a resorbable membrane Epiguide® both manufactured by Curasan AG, Germany.

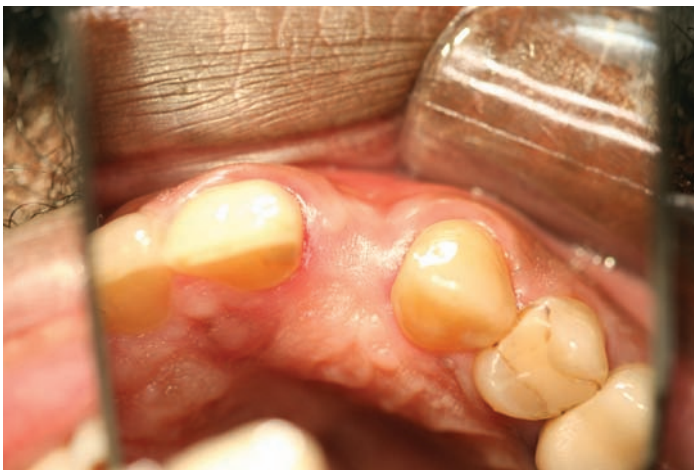
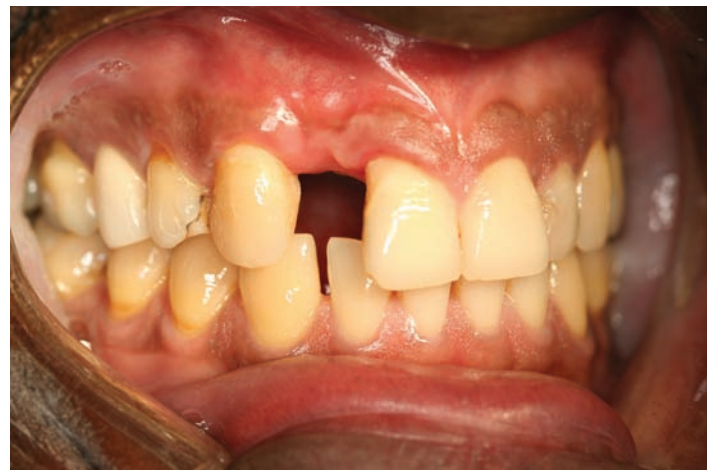
Fig. 10: Ridge post-graft occlusal view

Fig. 11: Ridge post-graft buccal view

Twelve weeks after bone grafting, a second CBCT was taken to assess the bone graft and bone anatomy in preparation for implant surgery. (Fig. 7, 8 - 9) Clinically the site was evaluated and found to have a favorable anatomy for predictable aesthetics. (Fig. 10 - 11) During the initial phases of the osteotomy it was subjectively determined that the

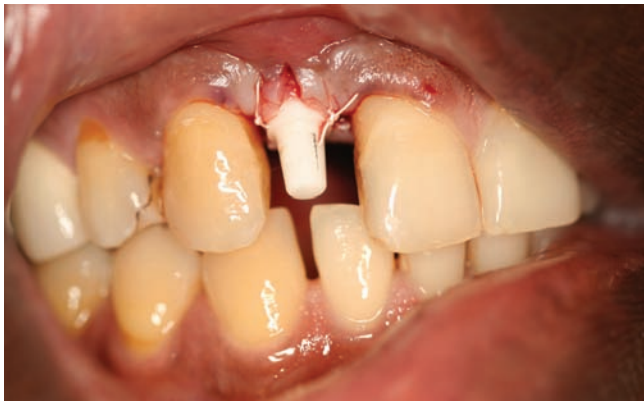
Fig. 12: Implant placed

bone was type II quality, a common clinical finding using ceramic bone as it fully resorbs and allows for autogenous vital bone to replace it. The osteotomy was however intentionally undersized and an insertion torque value of 55 Ncm was achieved and allowed for excellent primary stability of the implant (Fig. 12), no implant threads were exposed and no additional grafting necessary. An evaluation of the implant stability with a Periotest M (Medzinteknik Gulden, Germany) device (Fig. 13). The periotest measures implant stability by electromechanical percussion and measuring the implant's damping capacity thereby allowing for an objective assessment of implant integration/stability progress<sup>4</sup>. The values (PTV) of a periotest range from -8 to +50 with -8 being the highest measurement value of implant stability. Implant stability testing was done immediately after placement and PTV of an average of -4.3 were observed immediately after placement. The removable protective Essix appliance similar to the one in picture #14 was given to the patient to wear during the implant integration time. Two weeks later the patient returned for suture removal

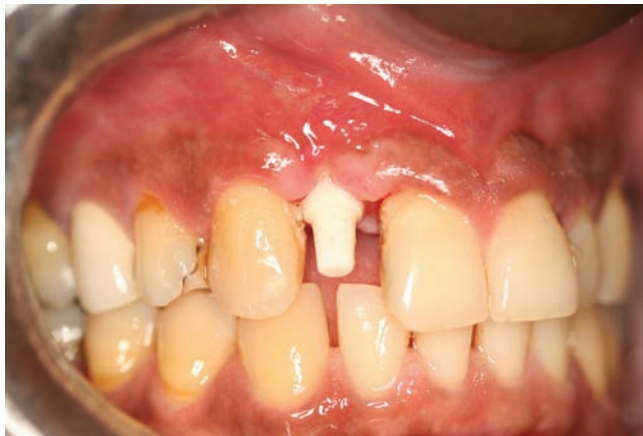
Fig. 15: Two weeks post-surgery

(Fig. 15) and healing of soft and hard tissue were in good progress. The implant stability was evaluated according to a schedule during four months of integration time (Table 1). Periotest values were collected at each post-surgery visit and the average values between the second and fourth week post-implantation initially declined to an average of -3.8 but improved up to -5.6 confirming more optimal stability<sup>4</sup> to proceed with the permanent restorative phase.

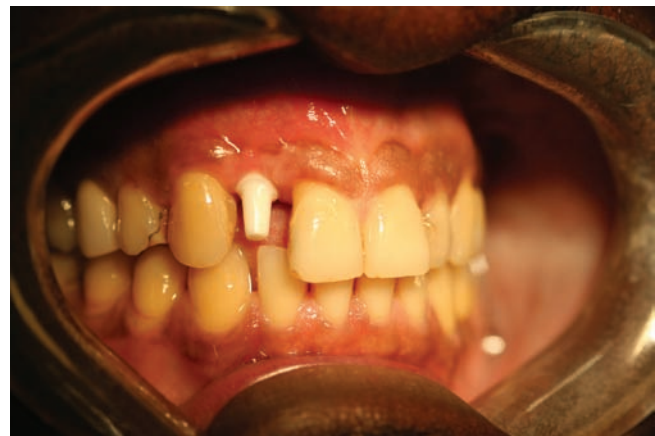
Fig. 16: Implant margin preparation

Four months after implant placement, based on clinical examination and after confirming implant stability, it was decided that for functional and aesthetic purposes, the implant would be restored with a porcelain fused to zirconia (PFZ) crown. The implant margin on the buccal that was supragingival was reduced to the gingival level (Fig. 16)

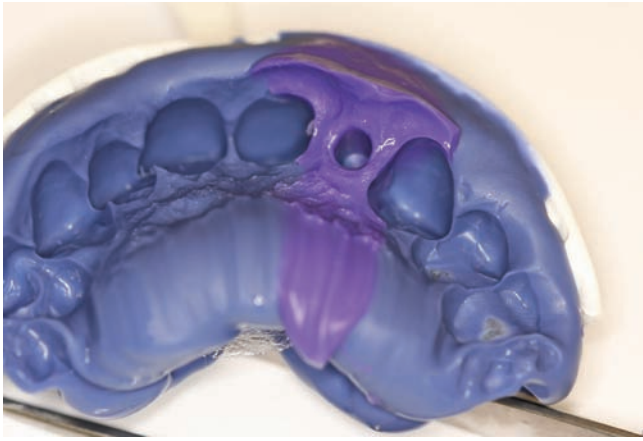
Fig. 17: Abutment level impression

and a conventional impressions of the prepared abutment and adjacent structures was made with light and medium body polyvinylsiloxane impression material. (Fig. 17)

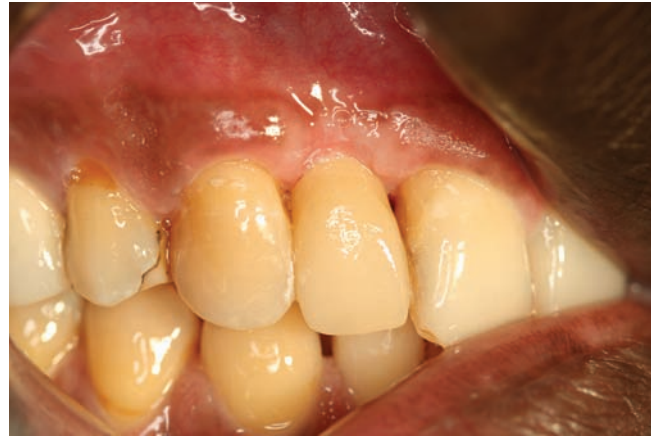
Fig. 21: Crown cemented

Both abutment and crown were then primed with Z-Prime (Bisco, USA) (Fig. 19) and permanently bonded with a resin modified glass ionomer cement (Fig. 20). The patient was satisfied with the aesthetic and functional outcome of this top-to-bottom metal free tooth replacement (Fig. 21). He

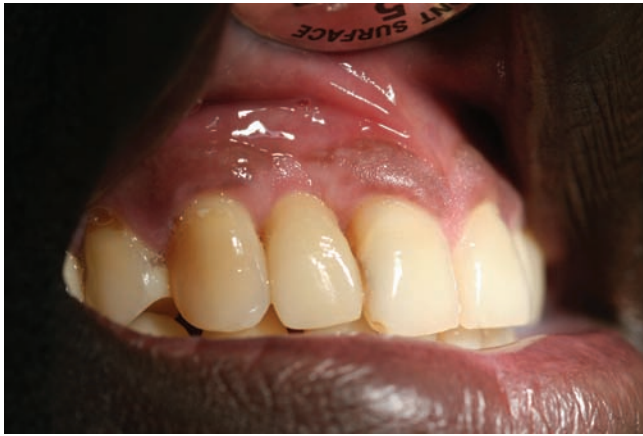
Fig. 22: Nine months post crown cementation

returned for uneventful post-crown delivery visit after 9 months (Fig. 22) and at two years both the restoration and implant are stable and functional (Fig. 23).
