Metal-Free Replacement of a Maxillary First Premolar with a Zirconia Ceramic Implant:

A Clinical Case Report

Dr. Sammy Noubissi

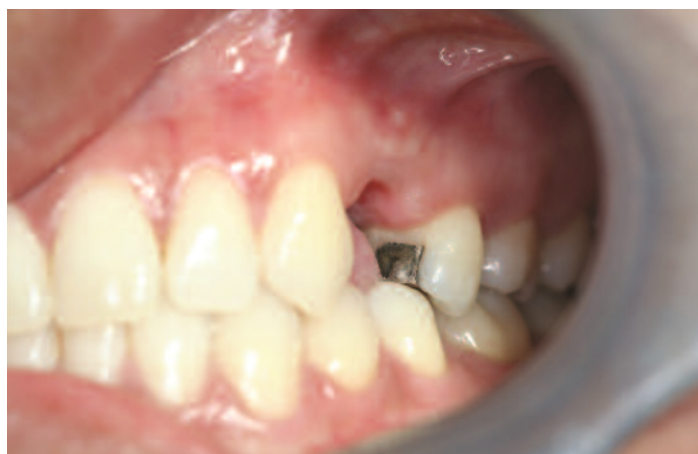
Figure 1: Pre-Op intraoral

A 27 year-old female presented with a missing maxillary left first premolar. The tooth which, according to the patient, had two rounds of root-canal therapy was extracted six weeks prior at another clinic in an emergency situation (Figure 1). Medical and dental histories were taken and clinical and a radiographic exam was performed as well. Clinical observation of the edentulous space suggested a defect in the buccal bone, and this finding was confirmed by the examination of the 3D (Figure 2), axial (Figure 3) and coronal slices (Figure 4) from the CBCT. The patient was informed that there was a chance that the implant would not be placed during the first surgery, and that the chances of immediate fixed temporization of the implant would be minimal. The treatment was established, and would consist of ridge augmentation, implant placement, interim prosthetics and permanent-fixed prosthetics. A review of the medical history revealed that patient reported no sensitivity to metals but preferred to have a tooth replaced with metal-free biomaterials.

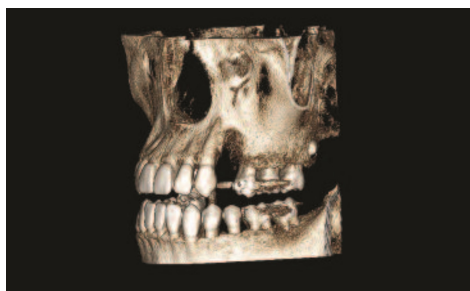
Figure 2: Pre-Op 3D view from CBCT

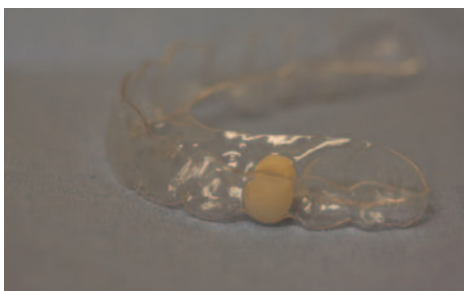
Figure 7: Implant protective/Essix appliance

In preparation of implant placement, impressions were also made in order to fabricate an implant protective device and a temporary crown (Figure 7) for the patient to wear during the implant integration into the bone. At the time of surgery, the patient was administered local anesthetic. A total of five carpules of lidocaine 2% with 1/100,000 epinephrine were administered, by infiltration, only in the areas extending distal of tooth #11 to mesial of tooth #14, both buccally and palatally. An intra-sulcular incision was made, and it extended from mesial of tooth #14 to mesial of tooth #11. A mucoperiosteal flap was raised, the bone was exposed, and the four-walled defect socket was visualized (Figure 8).

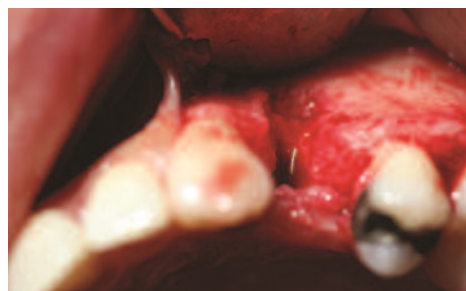
Figure 8: Buccal bone defect

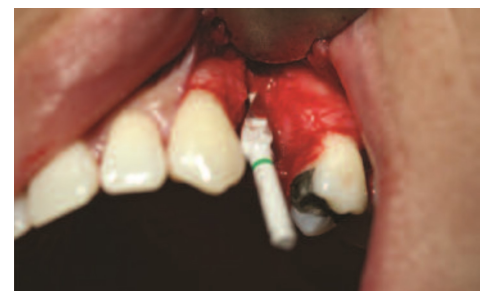
Figure 9: Osteotomy

The osteotomy was performed under sequential drilling using profuse irrigation, starting with a Loma Linda drill. This initial drill was positioned in a manner that the interradicular bone was engaged in a slightly palatal position, but emerging buccally at the coronal level (Figure 9). The following steps of the drill sequence were done in accordance with the Zirkolith surgical kit workflow for the selected implant configuration. During the initial phases of the osteotomy, it was subjectively determined that the bone was type II quality and, hence, favorable for

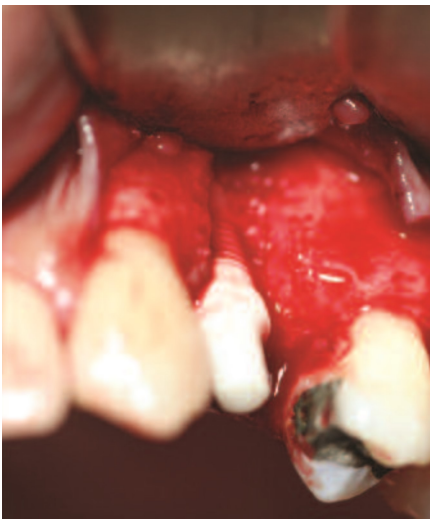
Figure 10: Exposed buccal threads

good primary stability of the implant. The implant was inserted at a speed of 20rpm, and a torque of 40 Ncm, two third of the buccal threads were exposed (Figure 10), and the stability of the implant was measured with a Periotest™ and recorded at a value of -3.6. Bone graft, using mineralized cancellous bone (PUROS, Zimmer AG), was placed to cover the exposed threads (Figure 11), and a resorbable collagen membrane (Figure 12) was placed. Two sutures were placed mesial and distal of the implant platform, and the temporary crown was provisionally cemented to the implant abutment. Three weeks later, the sutures were removed (Figure 13).

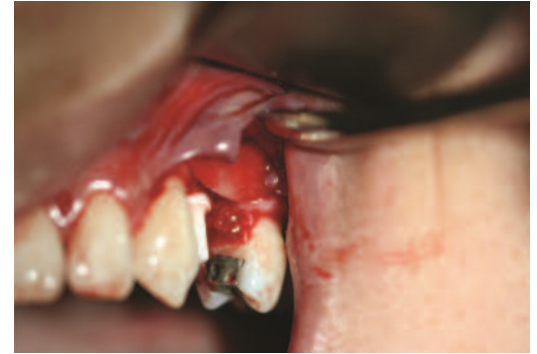
Figure 12: Collagen membrane

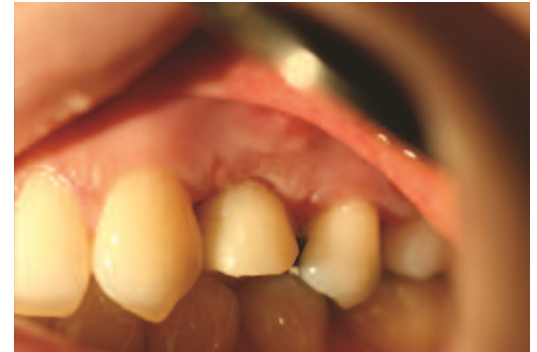
Figure 13: Provisional crown

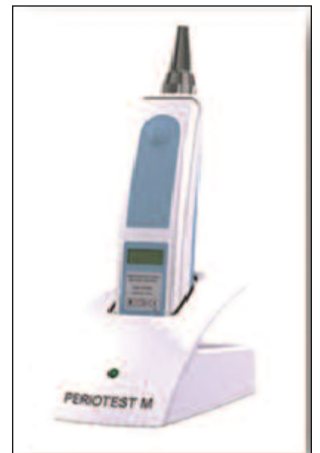
Figure 14: Periotest

Four months after implant placement, based on clinical examination and after determining adequate implant stability with the Periotest™ (Figure 14), it was decided that, for functional and aesthetic purposes, both the implant and tooth #13 would be restored with a porcelain-fused-to-zirconia (PFZ) crowns. Conventional impressions using a pick-up impression cap (Figure 15) of the implant and adjacent prepped tooth were made with light and medium body polyvinylsiloxane impression material (Figure 16), and a stone model made (Figure 17). Once the crown was received from the dental laboratory, the challenge was to bond two ceramics, namely the abutment and the crown together, in a predictable manner on the implant. The intaglio of the crown was decontaminated with Ivoclean (Ivoclar), and the abutment cleaned with alcohol. Both abutment and crown were, then, primed with Z-Prime (Bisco) (Figure 18) and finally bonded with resin-modified glass-ionomer cement. The patient was satisfied with the aesthetic and functional outcome of this top-to-bottom metal free

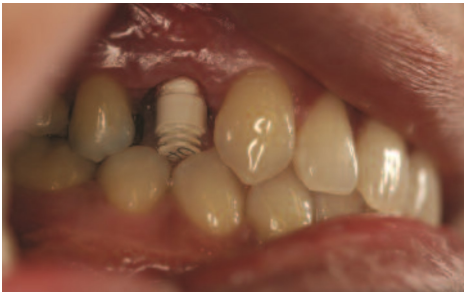
Figure 15: Impression cap on abutment

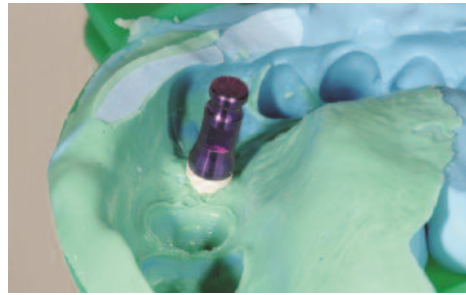
Figure 16: Impression

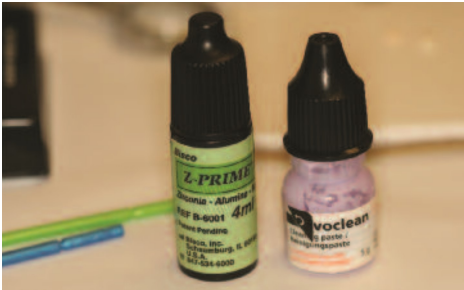
Figure 18: Cleaning and priming materials

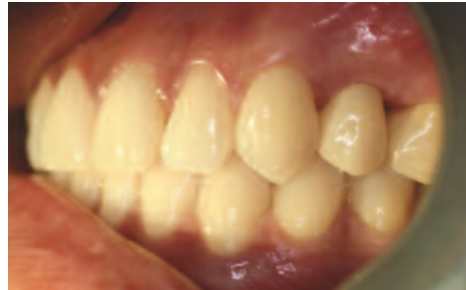
Figure 19: Immediate post crown delivery

tooth replacement (Figure 19). Three years later, the patient returned for additional dental procedures, implant #12 and tooth #13 were evaluated, and the red aesthetics had improved, since initial crowns delivery (Figure 20).

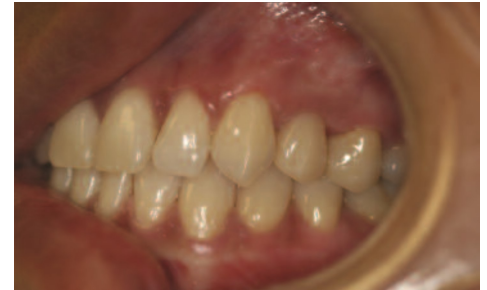
Figure 20: Three years post op
